Lead Based Paint Inspection & Risk Assessment

***10 Clifford Street Apt-101
Biddeford, Maine***

LEAD PAINT INSPECTION & RISK ASSESSMENT REPORT

REPORT NUMBER: S#03308 – 04/02/21 08:10

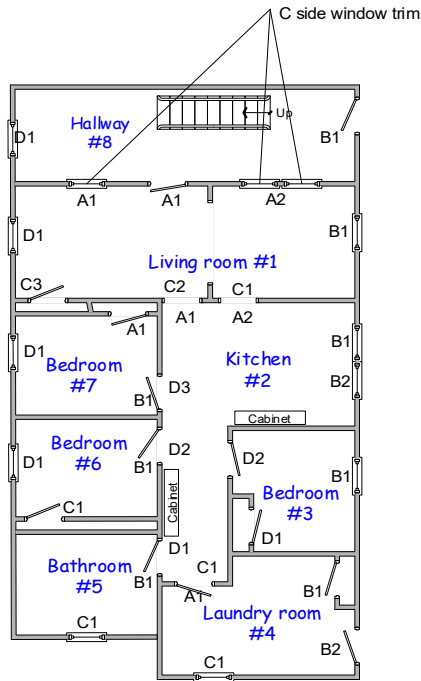
| <i>Room # and Name</i> | <i>Building Component</i> | <i>Location</i> | <i>Repair recommendation</i> |
|---|---|---|---|
| Living room #1 | Door & door jamb | C3 | Replace/ Encapsulate |
| Laundry room #4 | Door | B1 | Replace |
| | Window sash | C1 | Replace |
| Bedroom #6 | Door | C1 | Replace |
