# ***Lead Based Paint Inspection & Risk Assessment***

***10 Clifford Street Apt-201  
Biddeford, Maine***

# LEAD PAINT INSPECTION & RISK ASSESSMENT REPORT

**INSPECTION FOR:** BIDDEFORD Lead Hazard Control Program

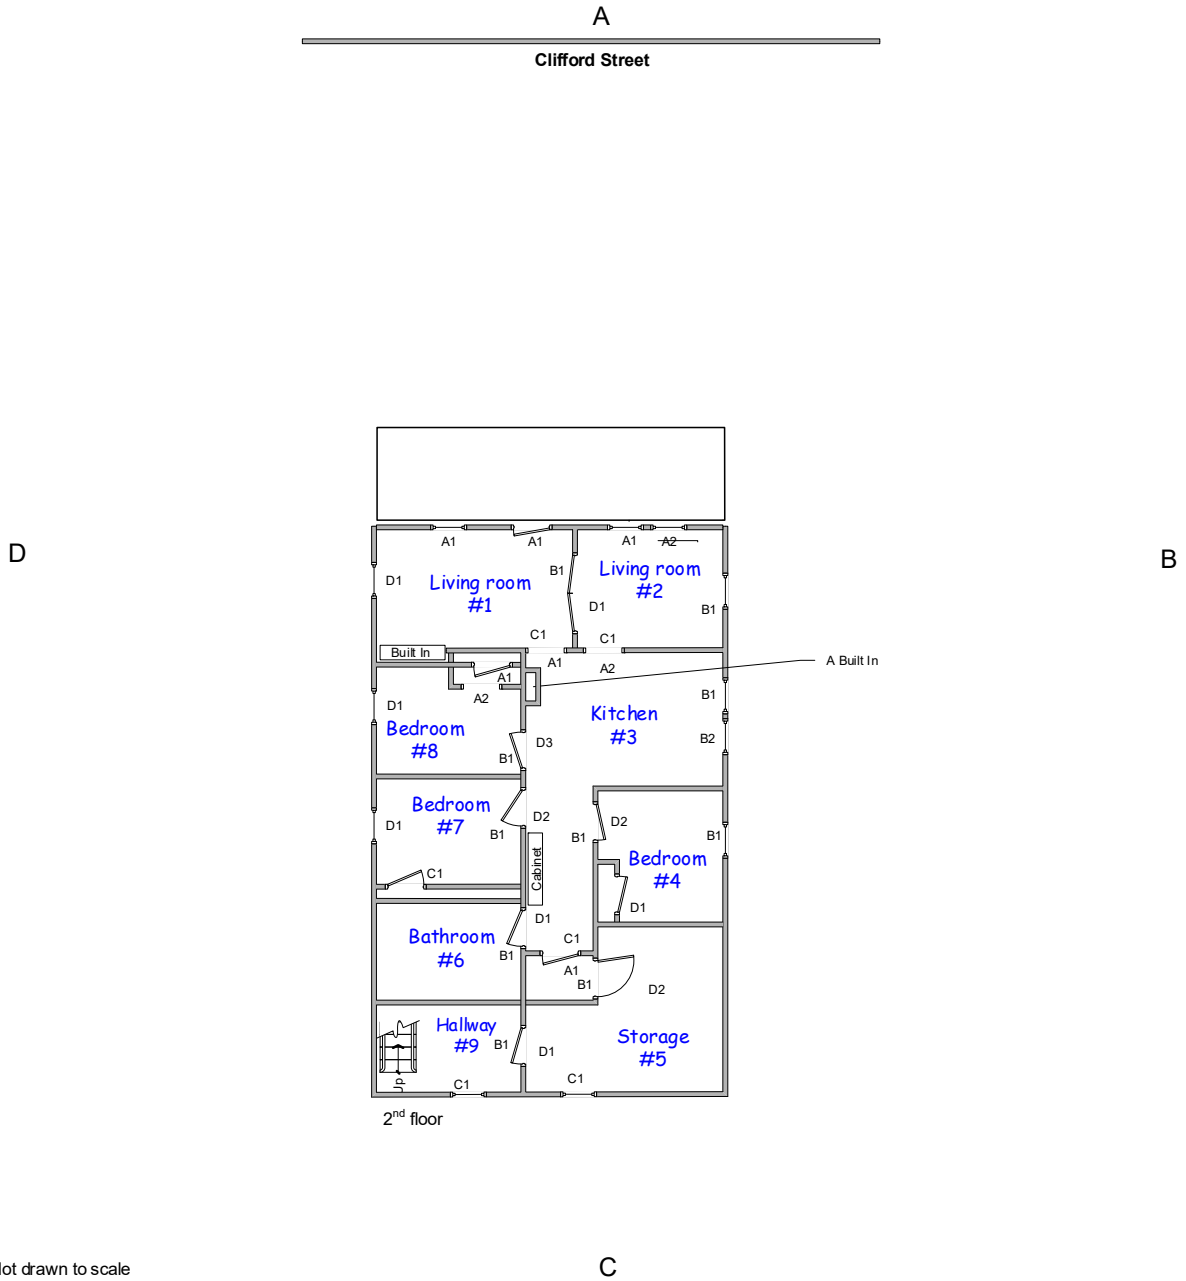
### Unit layout-2<sup>nd</sup> Floor Unit

The following list shows the type and location of those building components containing lead-based paint or assumed to contain lead-based paint in poor condition. These areas are by definition **Lead Hazards**.

<i>Room # and Name</i>	<i>Building Component</i>	<i>Location</i>	<i>Repair recommendation</i>
Exterior	Access door & casing	A side	Cover
<i>{Will be dressed in unit 001}</i>	Siding {located in entry to 001}	B side	Cover
Living Room 1	Window Sill & casing	A1,D1	Encapsulate
	Window Sash	A1	Replace
	Door Casing	A1, C1	Replace
	Door	B1	Replace
	Door Jamb	C1	STB Encapsulate
	Shelf, door & drawer	C side built-in	STB Encapsulate
	Window sill {dust}	All	Abate
Living Room 2	Window Sash	A1, A2	Replace
	Floor {dust}	All	Abate
Kitchen 3	Cabinet {Door, casing, shelf}	D side upper/lower	Remove & Replace
	Window trough & floor {dust}	All	Abate
Storage 5	Door	A1, D2	Replace
	Door jamb <i>{A1 addressed from kitchen on the design}</i>	A1	STB Encapsulate
	Floor	All	Cover
	Window Sash	C1	Remove & Replace
	Window trough & floor {dust}	All	Abate
Bathroom #6	Floor {dust}	All	Abate
Bedroom 7	Door <i>{B1 addressed from kitchen on the design}</i>	B1, C1	Remove & Replace

Door jamb <i>{B1 addressed from kitchen on the design}</i>	B1	STB Encapsulate
Bedroom 8	Door <i>{B1 addressed from kitchen on the design}</i>	B1	Remove & Replace
	Door jamb <i>{B1 addressed from kitchen on the design}</i>	B1	STB Encapsulate
