FINAL PROJECT REPORT

Thatcher Brook Restoration Project, Phase I – #2017RT11

Grantee: City of Biddeford

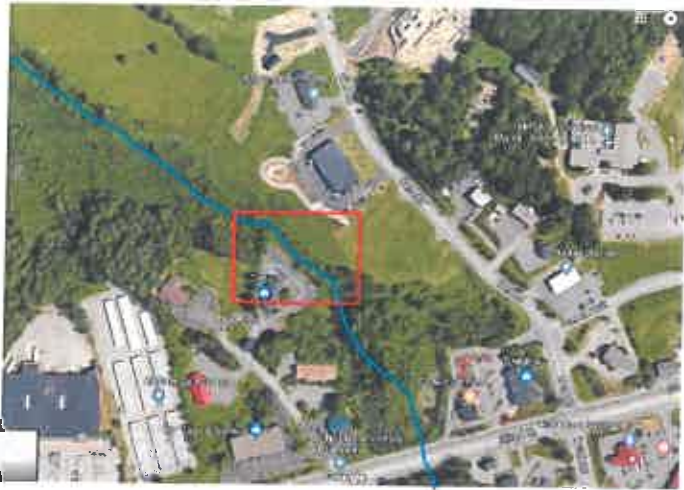
Buffer 1

Appendix A: Buffer Site Locations where letters were sent

Four buffer locations were chosen to establish mowing restrictions as well as potentially live stake these areas and solicit plantings from local businesses. No grant money was placed towards these projects, however these projects were supposed to contribute match for Phase 1. Please see Appendix A for reference locations of these properties. District staff had intended to visit each property, with assistance from the City of Biddeford and the Biddeford Conservation Commission. Unfortunately, no site visits were made, however a letter describing the grant and the benefit of mowing restrictions was sent to each landowner in 2019. If these landowners respond to the letters once Phase 1 has expired, the District will still reach out to work with these landowners to educate them of the importance of mowing restrictions and assist them in re-vegetating their buffers adjacent to Thatcher Brook.
